NAVAL POSTGRADUATE SCHOOL

THESIS

AN INVESTIGATION OF THE CORROSION
SUSCEPTIBILITY OF FLAME-SPRAYED AND
ELECTRIC-ARC SPRAYED ANODIC METAL COATINGS
OF ALUMINUM, ZINC, AND
AN ALUMINUM-ZINC ALLOY

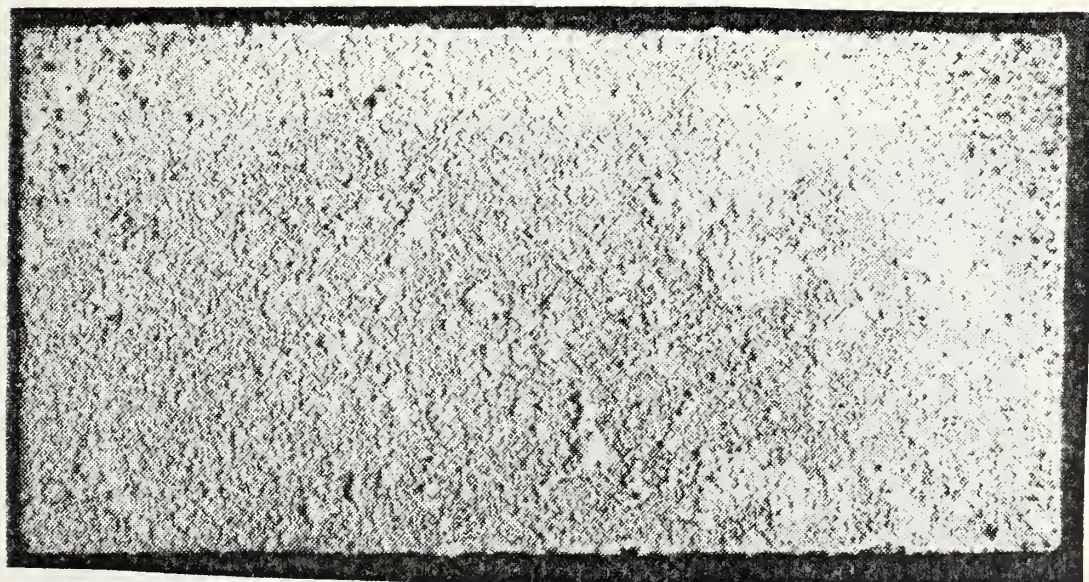
Figure B.57 Alloy A.S. coating, 70 days PIML

nodules continued to grow and the film increased in thickness. This can be seen in Figures B.56 and B.57. It is notable that the Alloy F.S. coating corrosion product growth rate seemed to start off high and end at a much lower level, while the growth rate of the A.S. coating seemed to remain relatively constant throughout the test.

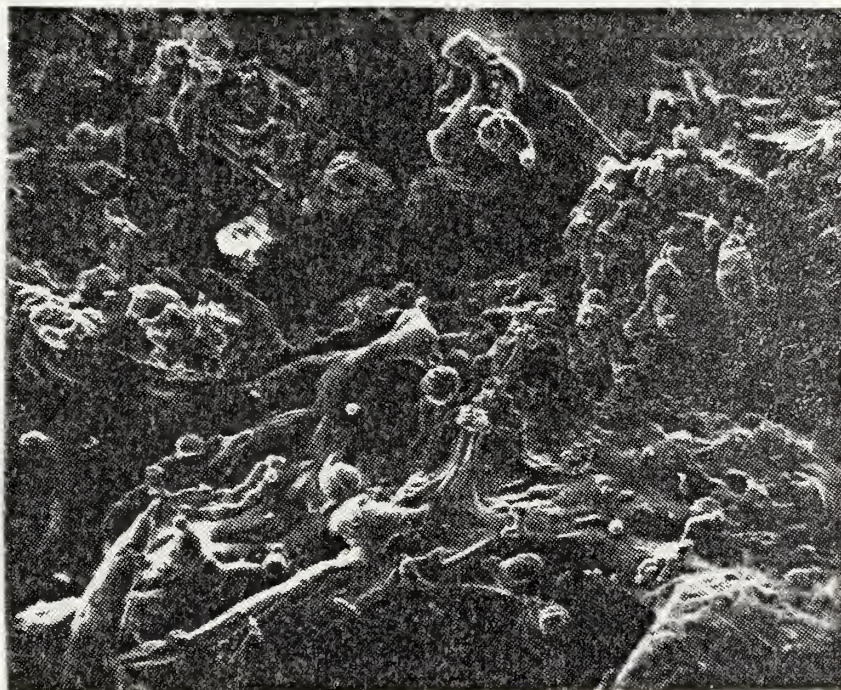
Figure B.69 (X155) Al A.S. coating, new, SEM

generally less cluttered, Figure B.69. Closer investigation of the corroding surface, Figure B.70, shows a snowy white, irregularly shaped corrosion product to be enveloping the coating surface. After four weeks, "mud-cracking" was visible, indicating that an oxide film had formed and was possibly aiding in corrosion prevention. These mud-cracks can be seen in Figure B.71. Aluminum and its alloys typically form a durable oxide film as a means of impeding corrosive attack [Ref. 22]. Six weeks after the start of the test the first significant signs of coating deterioration were observed. Figure B.72, shows one large surface excavation surrounded by several smaller indentations of lesser depth. PGT analysis of the large hole showed that this pit did not extend through the coating to the substrate. In another area of the sample, Figure B.73, shows the several forms that the attack was taking. At the extreme top of the micrograph can be seen a region that has suffered little from the corrosive attack; the destruction that has occurred is similar to that seen in Figure B.68. The center of this photo shows an area where the large puffy protruberances have been reduced to little stubs; finally, cracks in the protective film are visible at the lower right. During the seventh and eighth weeks the coating surface appears to have become more uniform. The corrosion seems satisfied to level any projecting remnants of the original surface. Figure B.74 shows the level landscape. By the tenth week the corrosion has turned

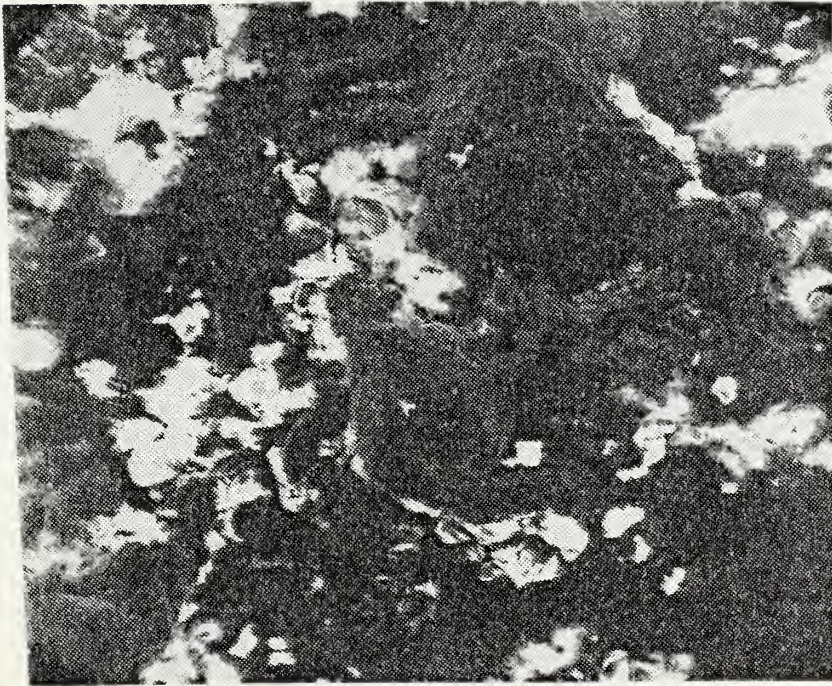
Figure B.74 (X110) Al A.S. coating, 56 days PIML, SEM
